MEMORANDUM

DATE February 8, 2016

RE Inspection Summary and Regulatory Issues @15753 SE Renton Issaquah Road, Renton WA 98059;
Parcel # 0638100031; (aka: Chuck Fillon Property)

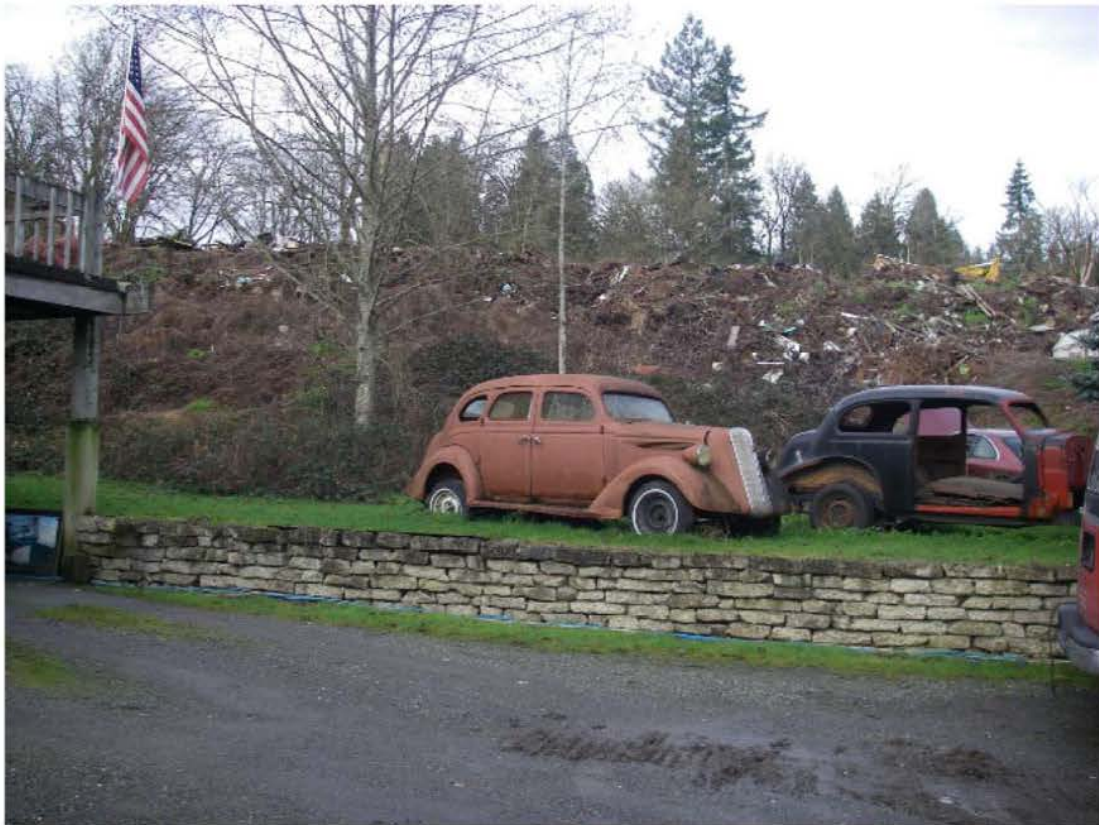
Figure 4. Largest "Compost" pile directly to right of Mr. Pilon's house. For reference, the ground that the vehicles are sitting on is the original surface of the property, and the pile is in the distance. This pile is approx. 25 ft. or taller, and Mr. Pilon stated that when he first bought the property you could see the bottom of the tree line that is behind the pile. This is the current, most active area that he has customers dump on. He said that he would either like to sell the "compost" in the future, as well as build a second house on top of this pile once it is fully settled.

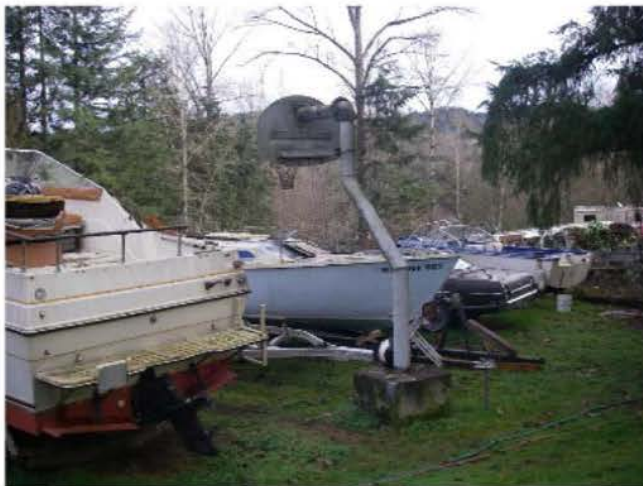
Wastes collected, stored, and piled at this facility include, but are not limited to: abandoned vehicles and vehicle parts (Figures 4-9); appliances and appliance parts; construction and demolition wastes such as wood, drywall, insulation, concrete, metal supports, roofing materials (Figure 12), carpet; discarded plastic, metal, and glass containers that contained food, chemicals, paints, and other liquid materials; bulk paints in containers; numerous discarded hot tubs; household wastes such as mattresses, furniture, CDs and DVDs, toys; yard waste, sod and soil waste, and various other materials made of wood, plastics and metals (Figures 10-11). Mr. Fillon attempts to do some sorting, and has some separate designated areas for tires, wood, and mattresses, but the bulk of the materials is mixed together into the piles, which he terms "compost." Although unlawful at this location, Mr. Fillon lacks the equipment, space, covered buildings, concrete padding, and manpower to conduct true sorting of materials for recycling, recovery or composting.

Figure 5 Vehicles

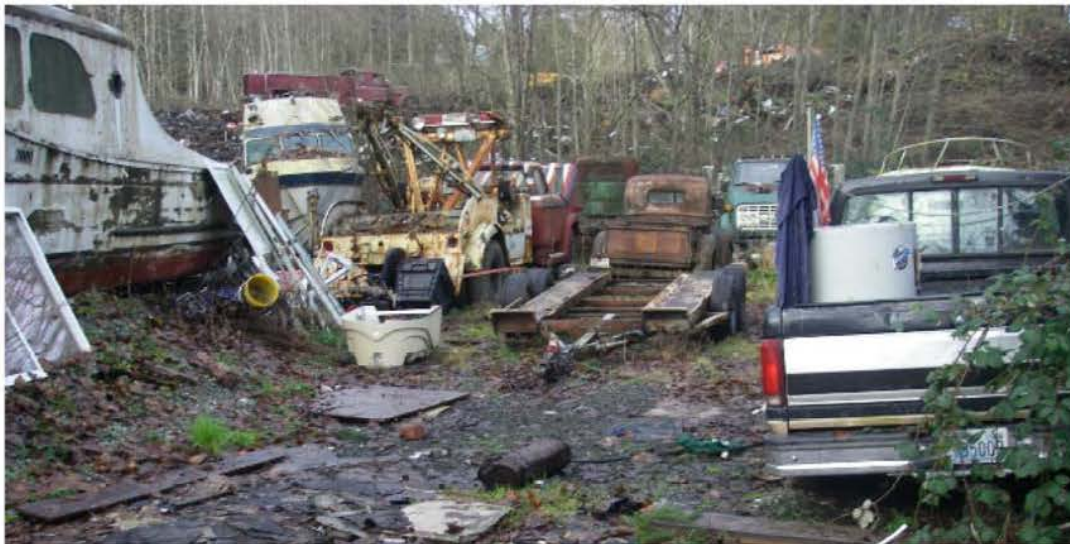
Figure 6 More vehicles

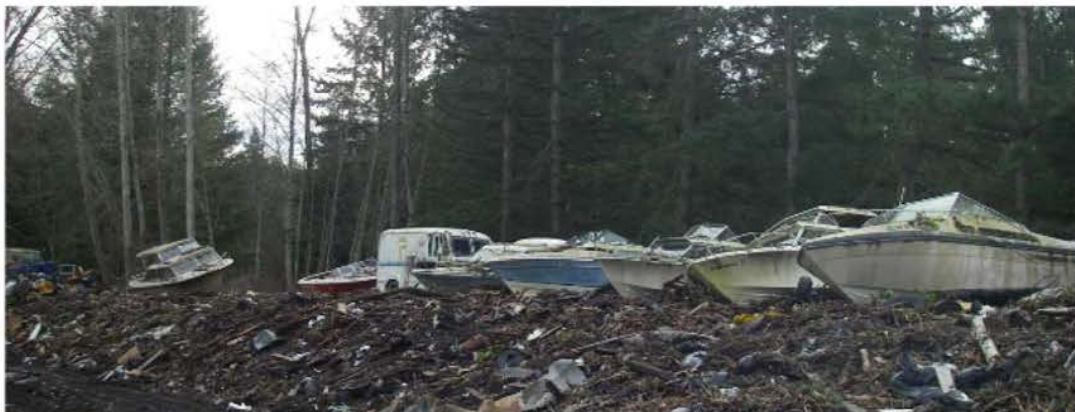
Figure 7 More vehicles

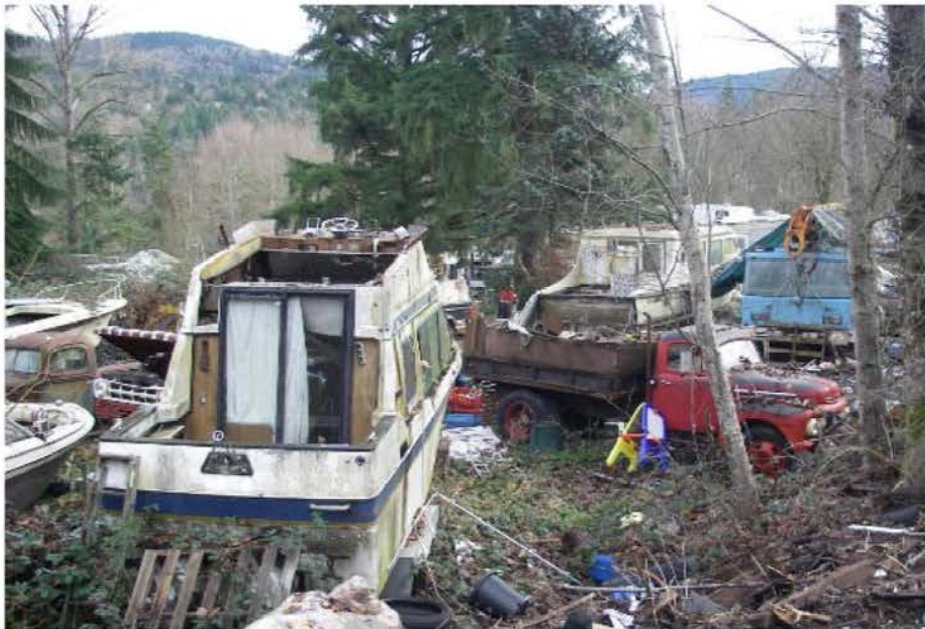
Figure 8 More vehicles

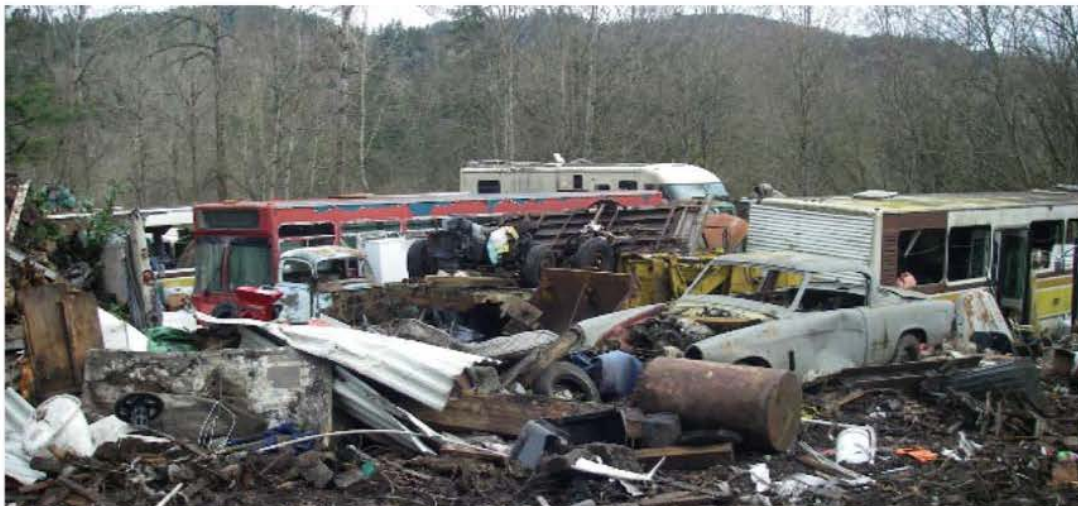
Figure 9 And some more vehicles. There are many more vehicles than are represented in these photos. Indiscriminate waste mixture in the foreground.

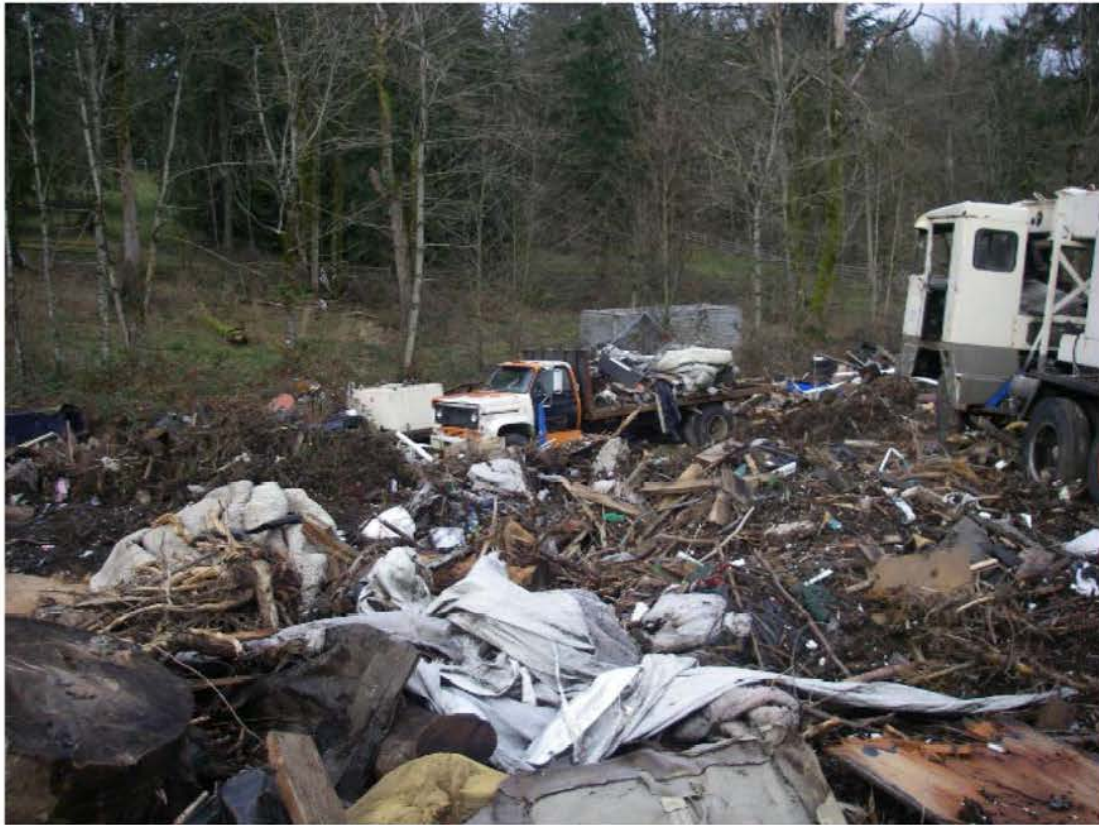
Figure 10. Vista at the top of the tallest pile. Example of indiscriminate mixture of wastes. Collection of mattresses on top of truck bed in distance.

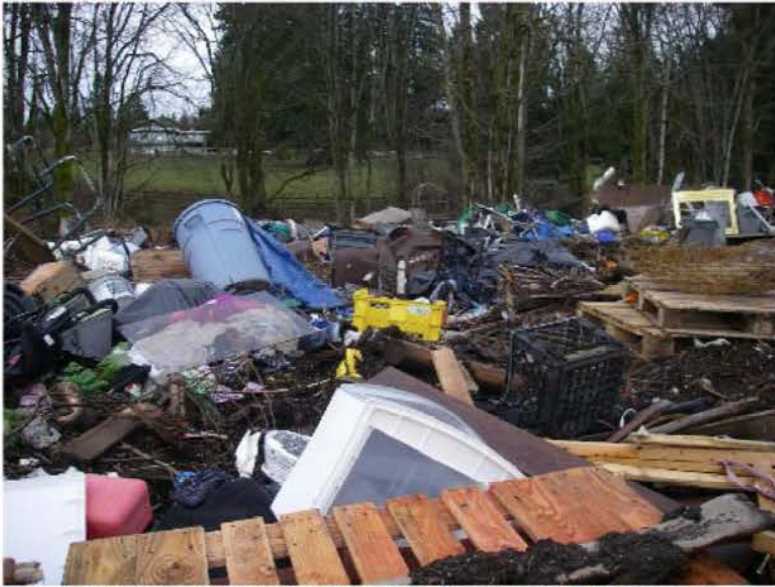
Figure 11. This photo is representative of the variety of wastes received at the property.

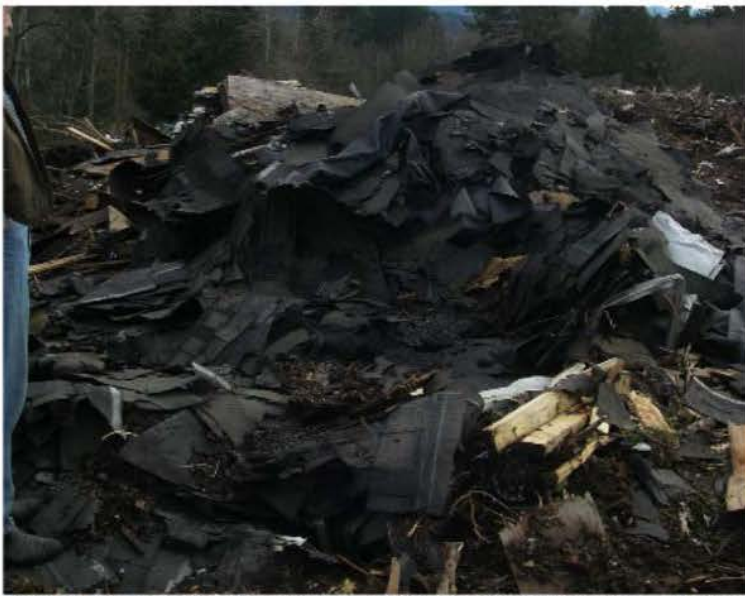
Figure 12. Pile of asphalt roofing material that he intends to line his driveway up to the largest pile for easier vehicle access

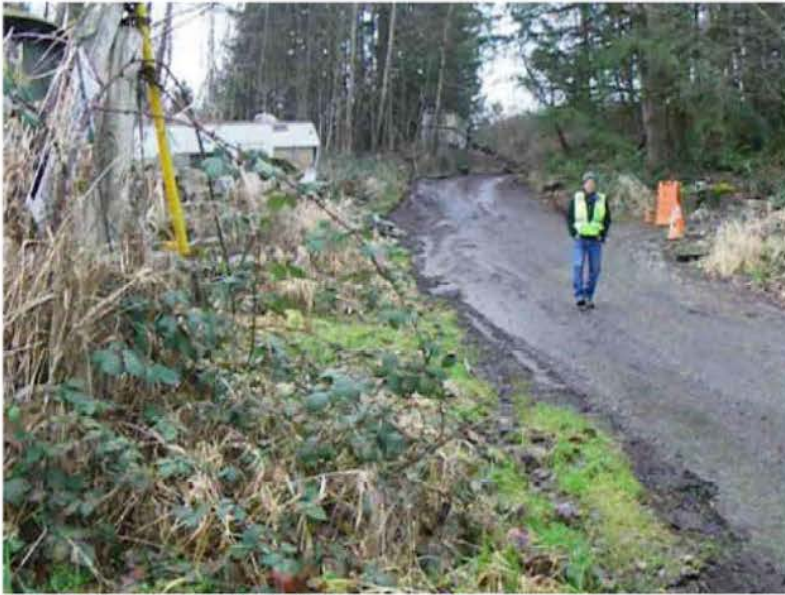
Observations: During the inspection, it was observed that Mr. Fillon has no controls to protect soil, surface water or ground water from contamination: all wastes were open to the elements, and his property is composed of slopes and piles. Essentially, precipitation is saturating the solid wastes and running off the wastes. We observed run off from the property onto the property access driveway and into a culvert which eventually discharges into May Creek (Figures 13-14). There is an adjacent property with pastured horses downslope from his property and the piles of waste. We inquired of Mr. Fillon if he has any environmental controls in place, and he said he does not. He stated that he has done soil and water sampling and the samples have been clean. He said he has done more recent sampling and said he would share those results with Public Health when they are complete. He also invited Public Health and agencies selected by Public Health to do their own sampling on his property, as he believes sampling will prove that there is no environmental contamination originating from his property.

Figure 13. Water runoff on left side of driveway into road

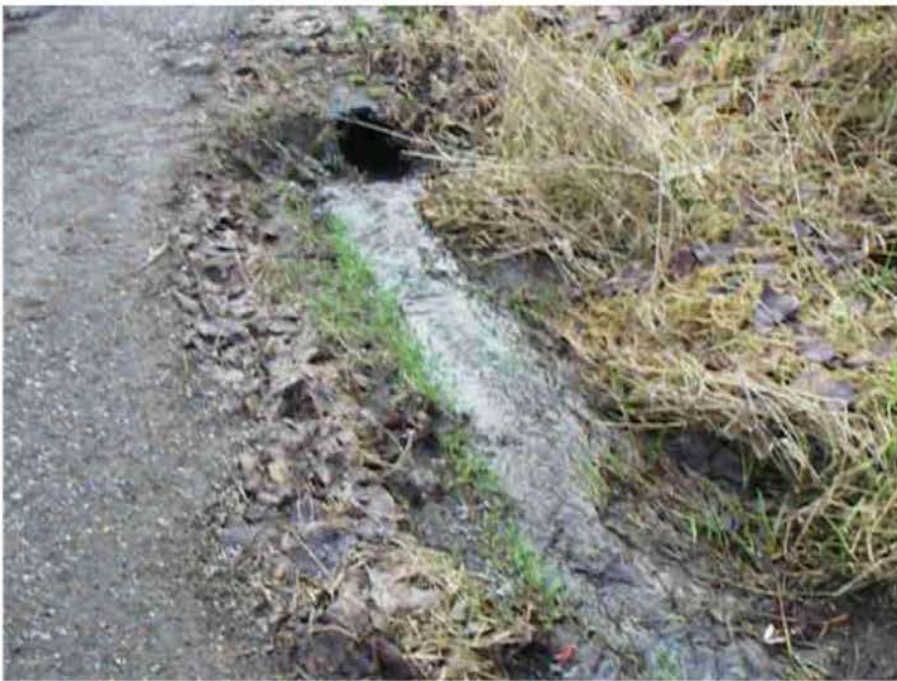
Figure 14. Significant water runoff from driveway on side of road leading to a tributary to May Creek
